ECOLOGICAL RESTORATION INSTITUTE  
Working Paper 44

Mitigating Postfire  
Runoff and Erosion in the  
Southwest using Hillslope  
and Channel Treatments

January 2021

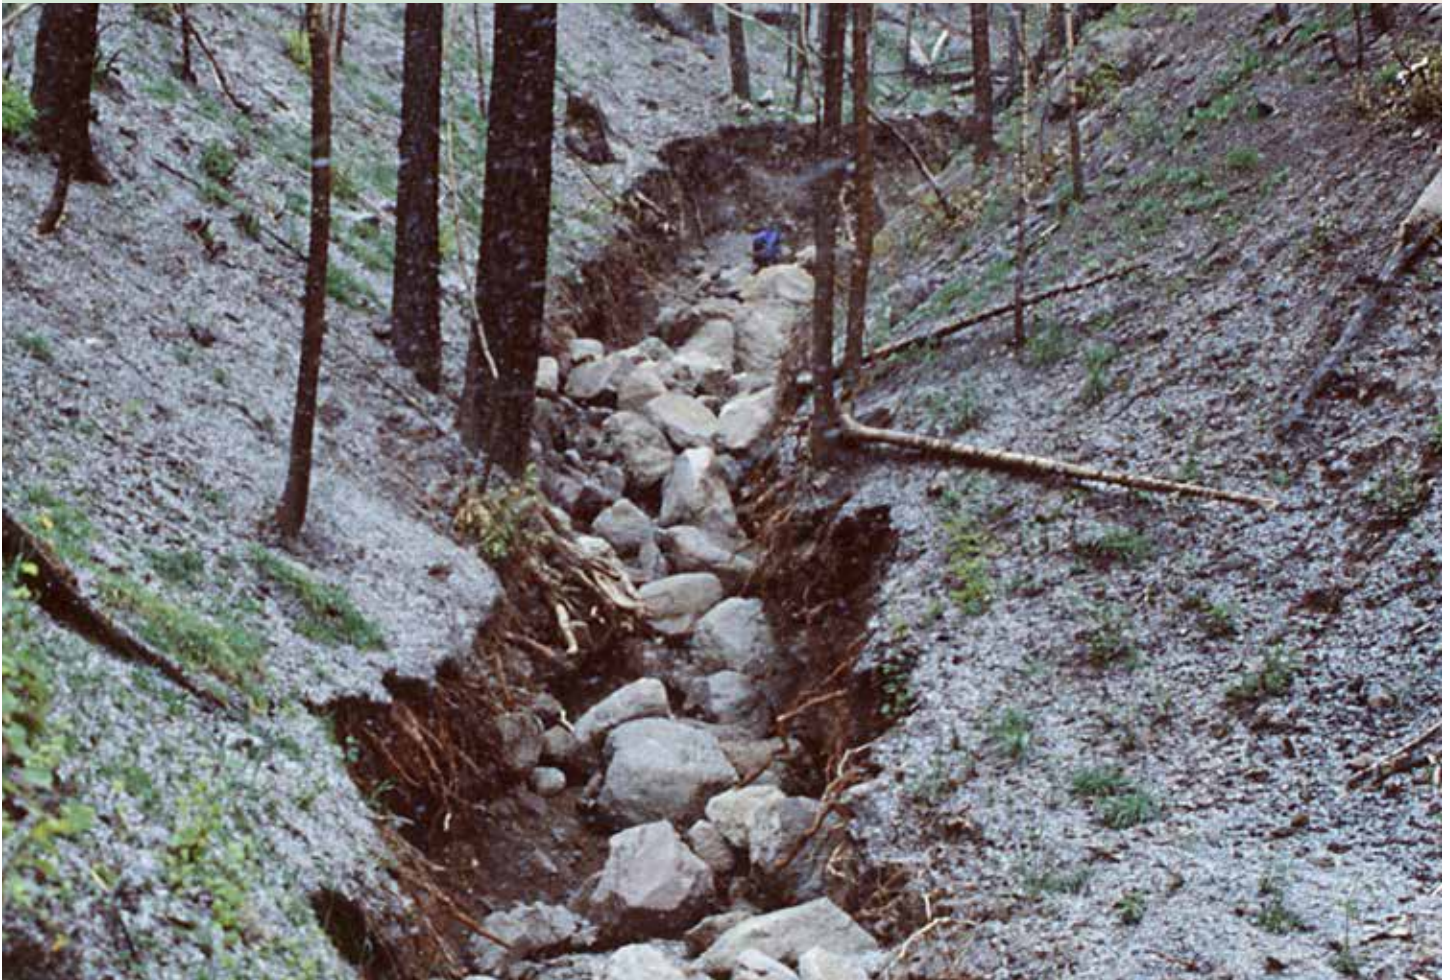
**Cover photo:** An incised channel created by the erosion of a drainage after the Cerro Grande Fire in 2000 near Los Alamos, NM. The view is upstream and the blue backpack is about 3 feet tall. The incision seen in this photo was after the wildfire and subsequent rain storm; this drainage had no definite banks prior to the storm. *Photo by John A. Moody, US Geological Survey*

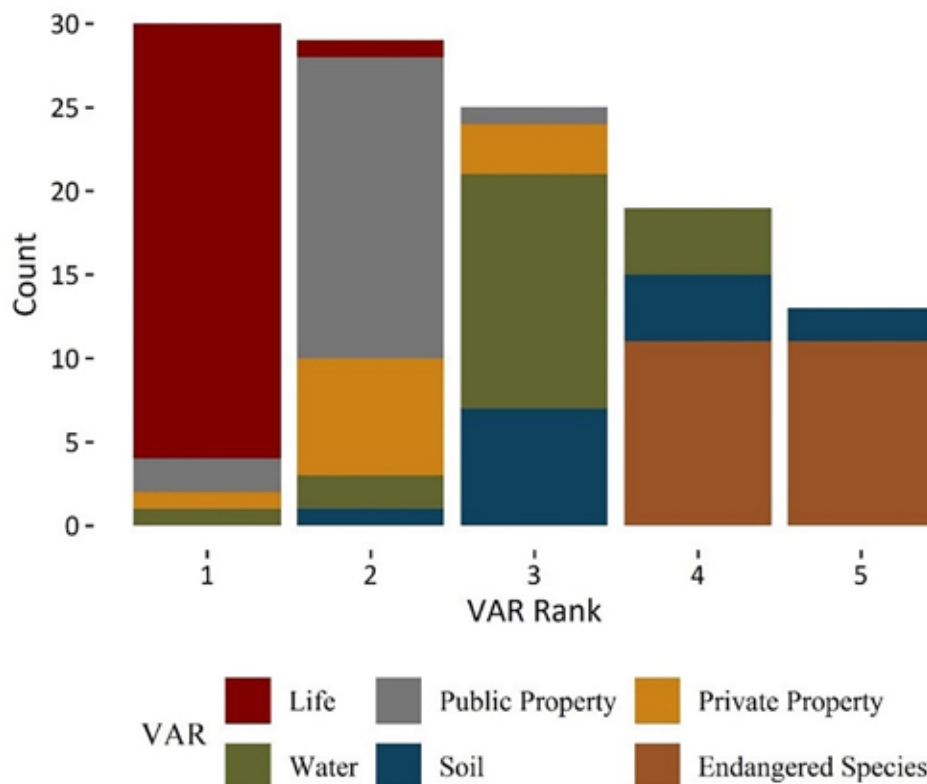
**Figure 2.** Values at risk (VAR) for the 30 largest BAER funding requests in the Forest Service Southwestern Region, 2000–2019. VAR rank refers to the order in which each value appeared. Adapted from Robichaud et al. (2014).

To justify treatments for mitigating risks to values, the DOI and USDA mandate that teams complete a cost-risk analysis. The cost-risk analysis consists of weighing the potential damage to values when no treatments have been applied compared to the costs of applying treatments. To provide a better understanding of how BAER funding is justified, we examined values at risk from the 30 southwestern fires with the most expensive BAER treatment requests. Life and safety was the highest-ranking value on 26 fires, and public property was the second highest

(Robichaud et al. 2014, Fig. 2). Federal land management agencies do not have the legislative authority to spend money outside of their jurisdictions. Because of this, agencies usually can only justify treatments based on values on federal property, but protecting private property is sometimes cited in funding requests (Fig. 2). When teams identify values at risk that are not on federal property, they collaborate with the Natural Resources Conservation Service (NRCS), and state, county, and local land management agencies to ensure that partner needs are met.

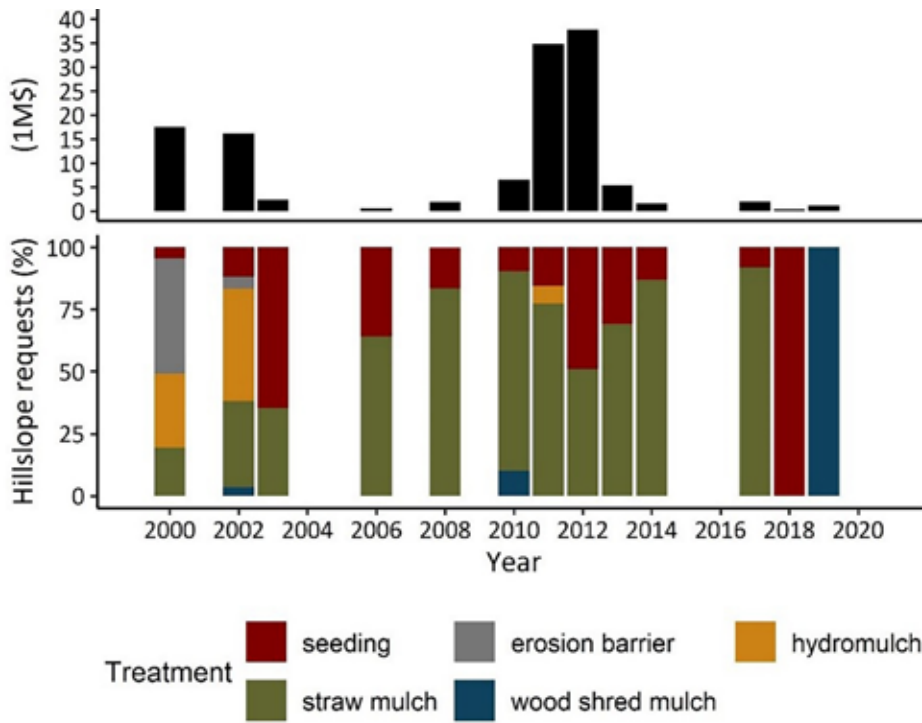
**Figure 3.** Total funding requests for hillslope treatments and percentages by treatment for the 30 largest BAER funding requests in the Forest Service Southwestern Region, 2000–2019. Dollar values are in millions and are adjusted for inflation to 2019 values.

Hillslope erosion treatments are designed to reduce postfire hillslope erosion and runoff from fire-affected hillslopes and to protect downstream resources by reducing flooding and sediment deposition (Robichaud et al. 2010). Hillslope erosion treatments include three major categories: 1) erosion barriers, 2) mulching, and 3) seeding (Napper 2006). The majority of recent hillslope treatments include straw mulch, wood shred mulch, and less often seeding (Fig. 3).

The use of postfire mulching has increased dramatically in recent years, as it has proven to be effective at reducing hillslope erosion (Robichaud et al. 2010; Fig. 3). Robichaud et al. (2010) reviewed studies on the effectiveness of three types of commonly used materials: 1) hydromulch, 2) agricultural straw mulch, and 3) wood shred mulch. Additionally, soil tackifiers such as polysaccharides or polyacrylamides have been applied as hillslope treatments either on their own or in conjunction with mulches (Robichaud et al. 2010).

(Napper 2006, Fig. 3). These attributes make straw mulching an effective tool at mitigating risks to even the most important values, such as human life and safety and public property, by reducing runoff peak flows and erosion that can damage infrastructure. Its relatively low cost per acre compared to wood shred mulching also make it useful when less critical values are at risk, such as municipal water sources (Table 1). Finally, straw mulch can be bought and shipped economically, and because of its low density is quickly installed, an important consideration in the Southwest where damaging storms can arrive days to weeks after fires burn. Potential risks of straw mulching are the

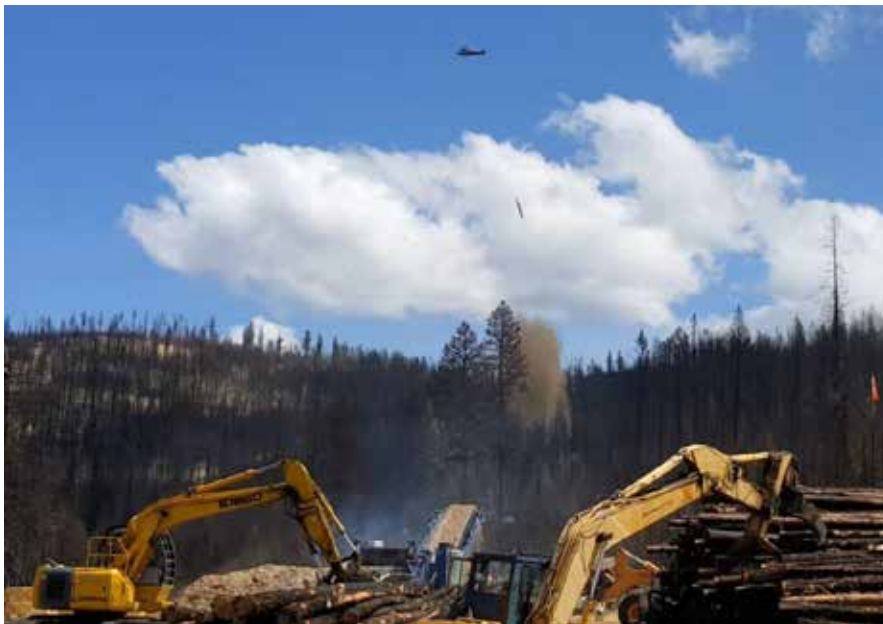
**Figure 4.** Wood shred mulch grinding and spreading via helicopter, Stickpin Fire, WA. Photo credit: Jason Jimenez, Colville NF.

Wood shred mulch, also known as wood strand or wood straw, consists of linear wood fragments usually generated on site from burned low-value timber (Fig. 4). Wood shred mulch is a new treatment but has gained popularity due to its effectiveness at reducing erosion, longevity on hillslopes, resistance to wind erosion, and local availability of materials, thus decreasing the possibility of invasive species encroachment (Table 1, Fig. 3). This comes at a high average cost of implementation of \$1,486 per acre and a relatively slow implementation time of ≈35 acres/helicopter/day, due to its high density (Robichaud et al. 2013a).
