The Plan That Wasn't Planned Working with People on the Land After the Flames Pine Gulch Fire BLM Grand Junction Field Office, 2020

> Chris Holbeck – National Park Service Erin Kowalski – Bureau of Land Management Mary Ellen Miller - PhD, Michigan Tech Research Institute Kevin Hyatt – Bureau of Land Management

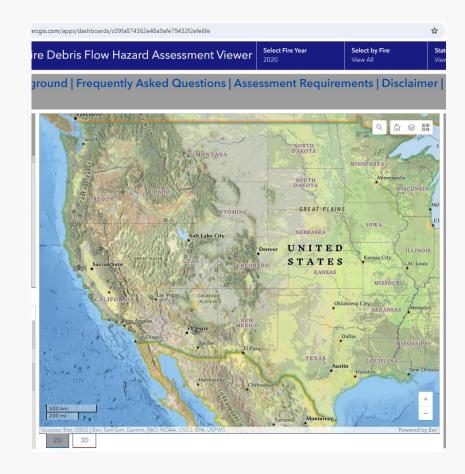
## USGS Post Wildfire Debris Flow Hazard model

• The USGS Post Wildfire Debris Flow predictions rely on empirical models to gauge the probability and magnitude of debris flows. Models were built using historical debris flow occurrences and magnitudes.

- Model Inputs:
  - differenced normalized burn ratio image (dNBR),
  - Soil Burn Severity data
  - Digital Elevation Model
  - Soils data
  - Precipitation
- Model outputs:
  - Probability of debris-flow occurrence given a peak 15-minute rainfall intensity.
  - Debris-flow volumes at the basin outlet and along the drainage network in cubic meters.

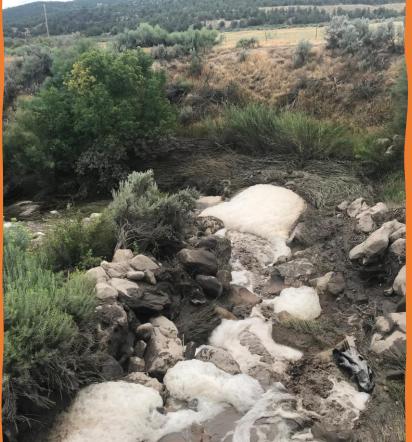
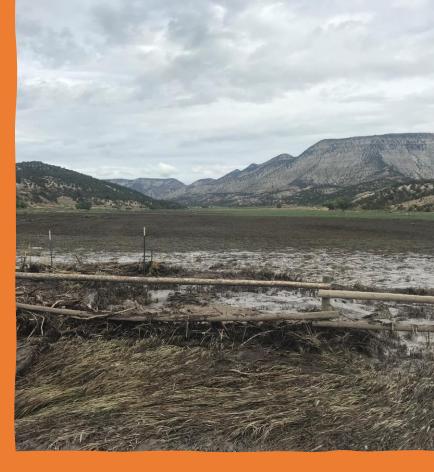
## N. Dry Fork

- Plugged Box Culvert
- Flooded agricultural field
- Down stream erosion
- 8/16/22
